WINSOR DAM MA 00588
QUABBIN SPILLWAY MA 00589
GOODNOUGH DIKE MA 00590

PHASE I INSPECTION REPORT
NATIONAL DAM INSPECTION PROGRAM

DEPARTMENT OF THE ARMY
NEW ENGLAND DIVISION, CORPS OF ENGINEERS
WALTHAM, MASS. 02154

SEPTEMBER 1978

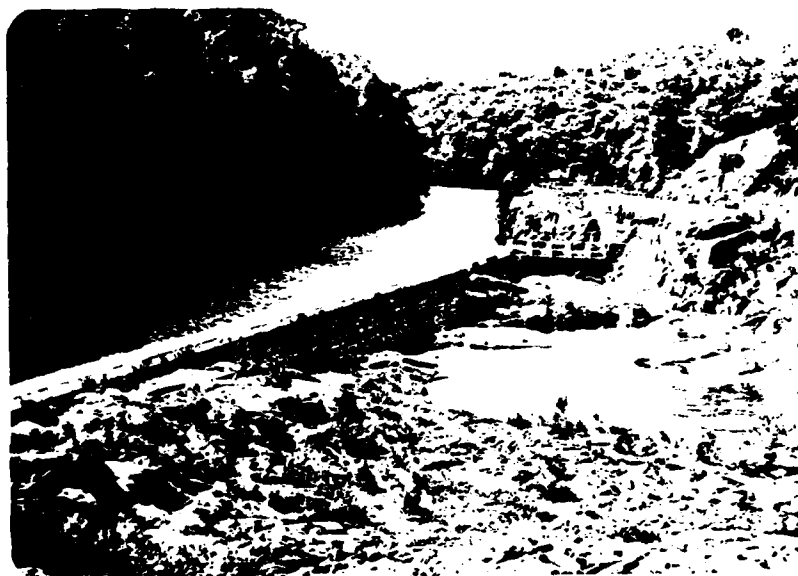
Overview Photo of Winsor Dam

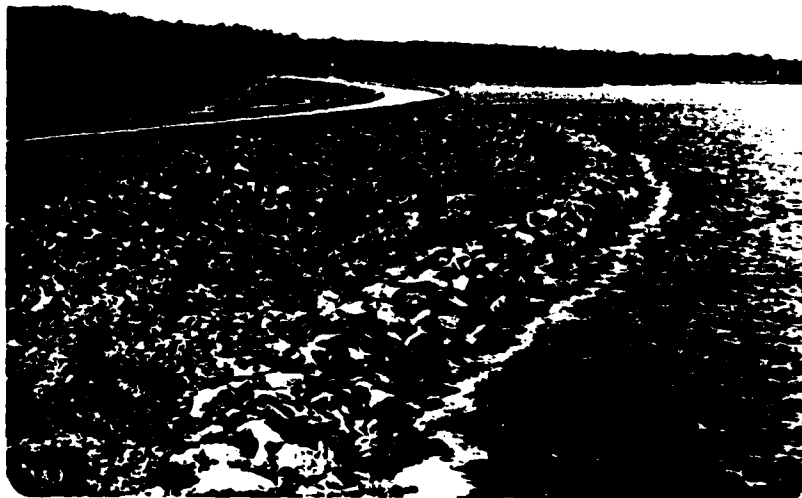
4. Upstream Slope Near Left Abutment

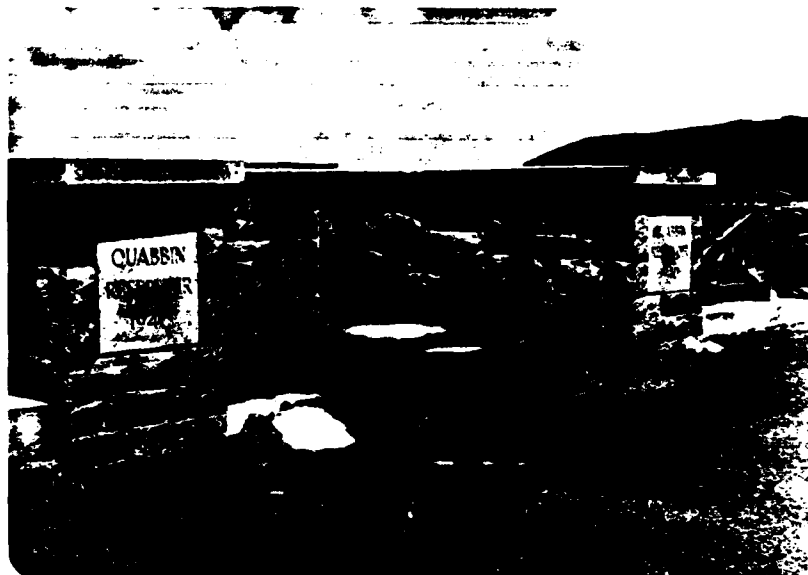
7. Stone Masonry Walls at Roof Level, Intake Structure

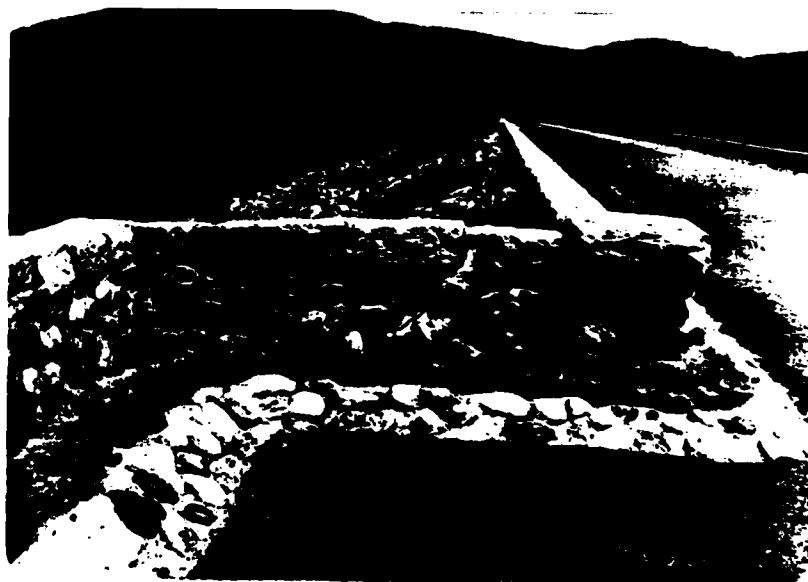
8. Stone Masonry Wall Left of Intake Structure

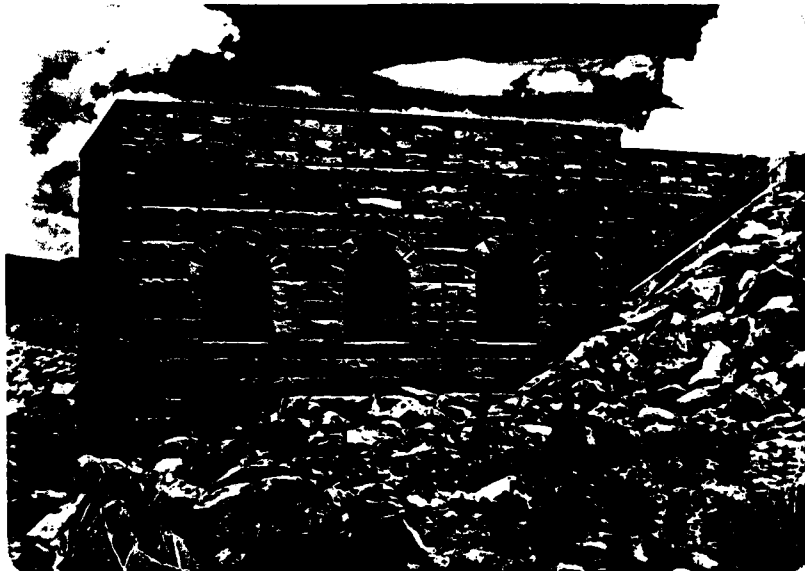
9. Intake Structure

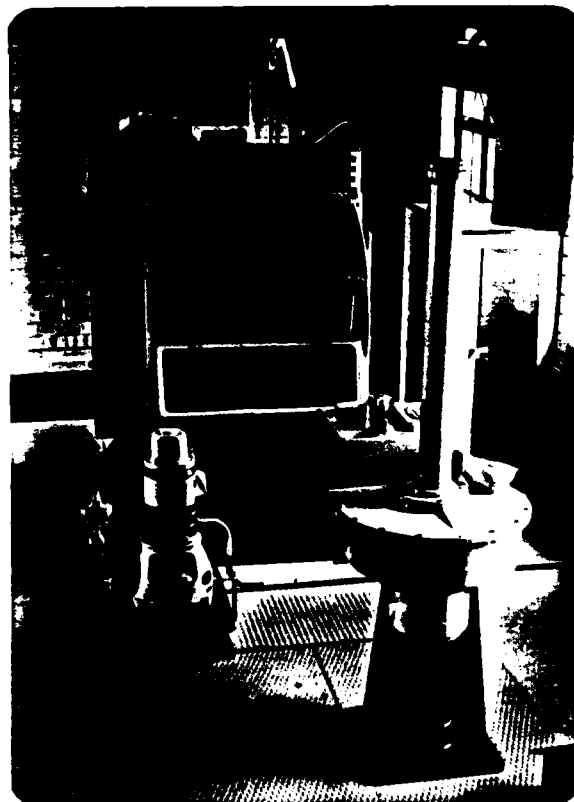
10. Gate and Screens
Inside Intake
Structure

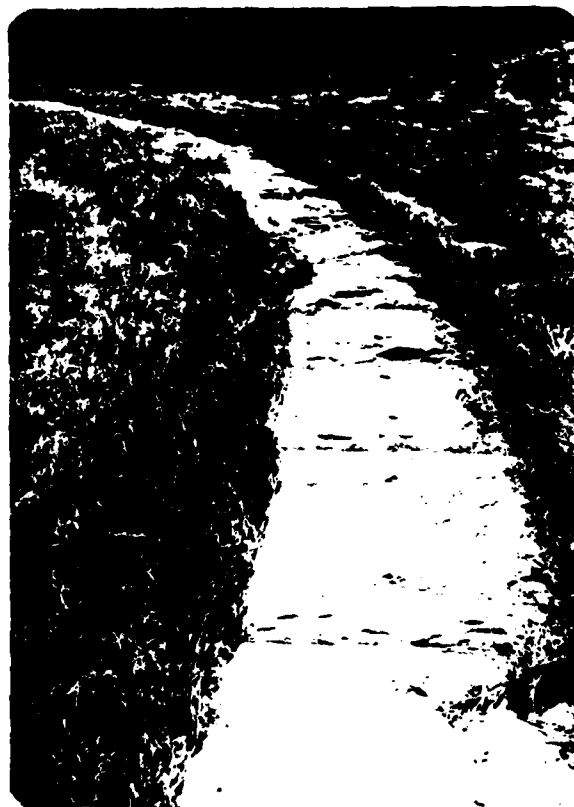
12. Crest of Auxiliary
Spillway

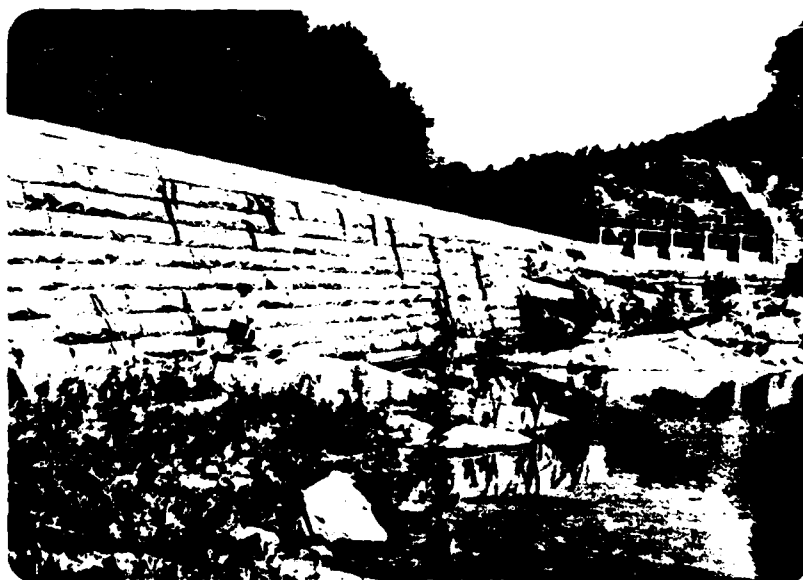
15. Spillway Weir and Bedrock, Water Flowing From Drill Holes

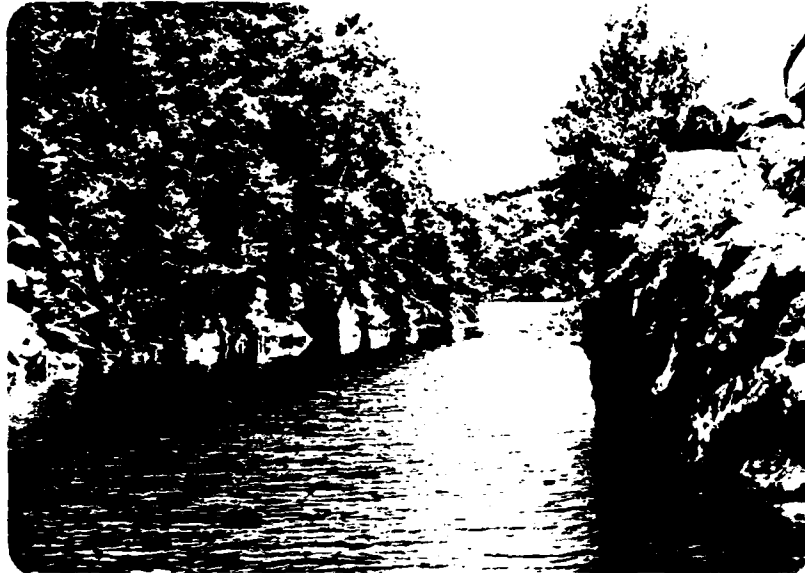
20. Side Spillway and Walkway

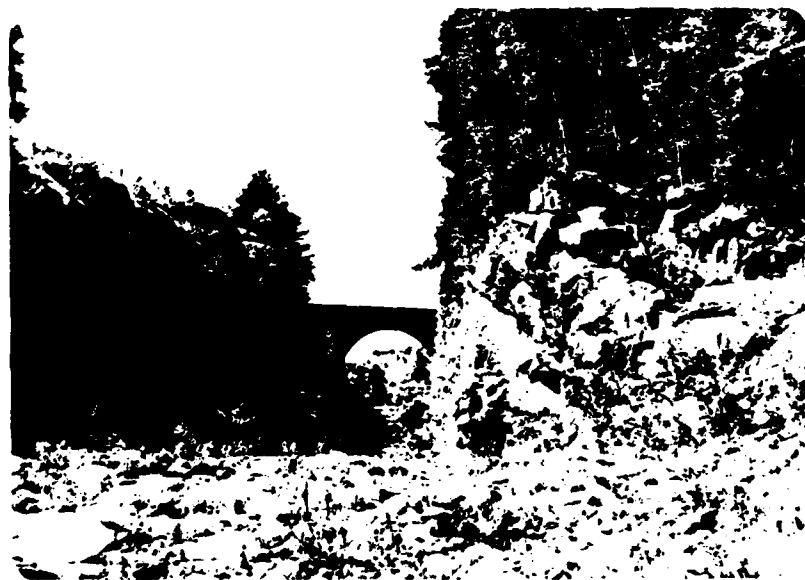
21. Approach Channel to Spillway

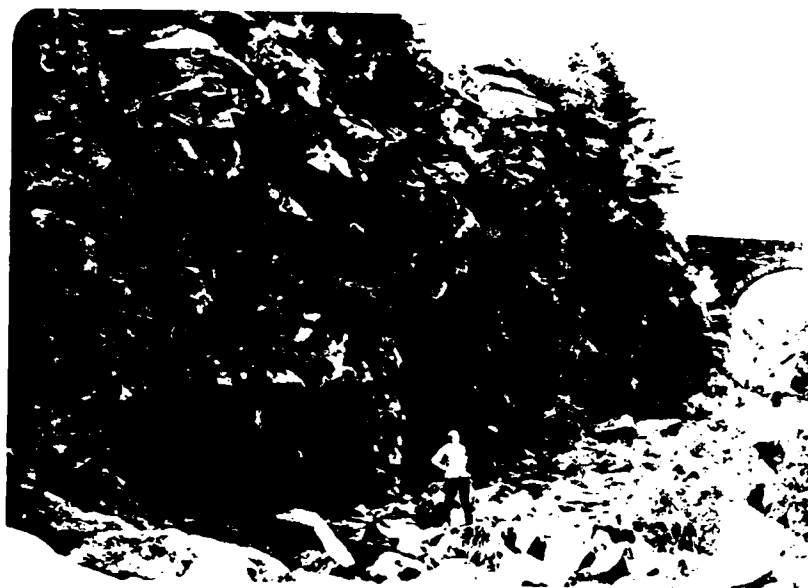
22. Discharge Channel From Spillway

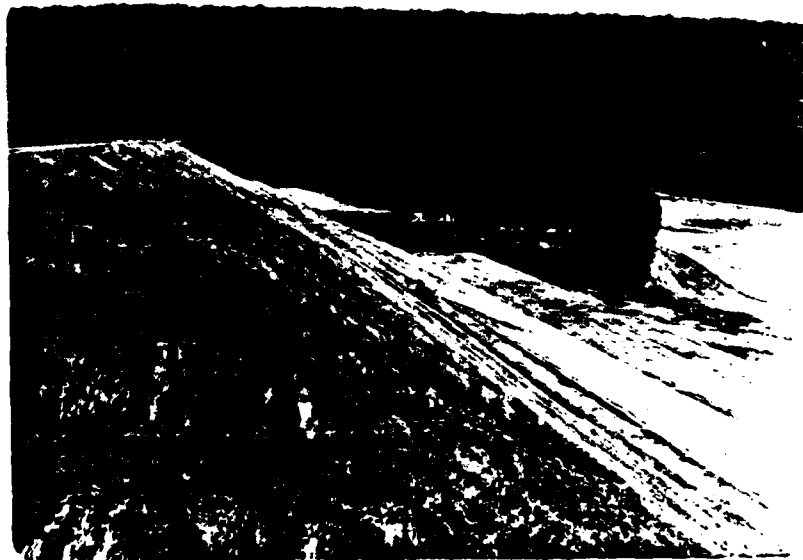
27. Roadway Across Embankment

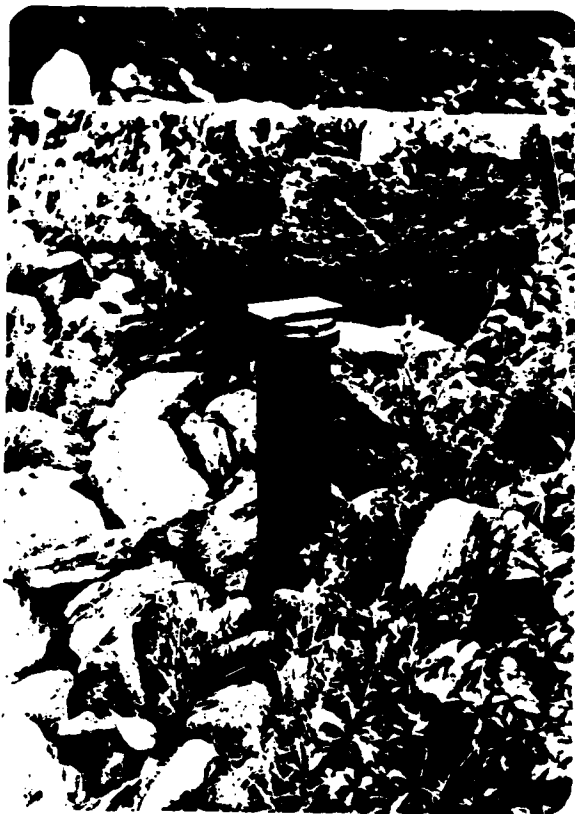
32. Upstream Slope
